***FAILURE
ANALYSIS
CASE
STUDIES II***

Edited by
D.R.H. Jones

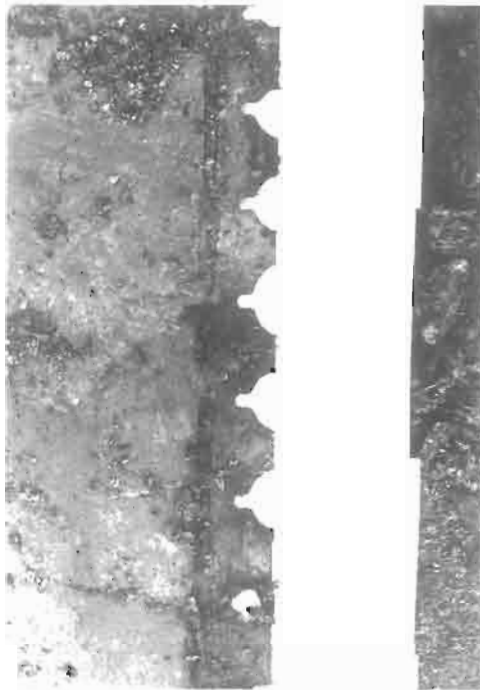
Fig. 4. Longitudinal bolted joint, presumably at location of start of rupture.

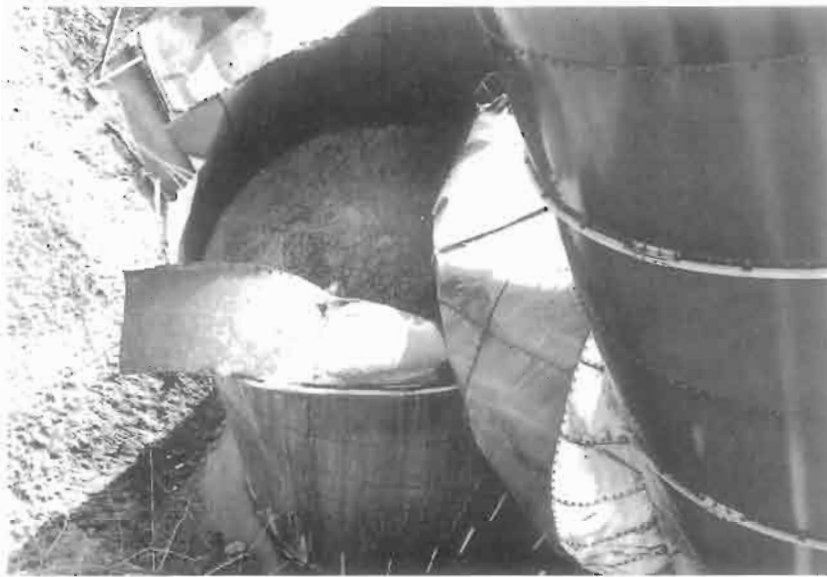
Fig. 5. Top view of failed silo, showing remaining filling level.

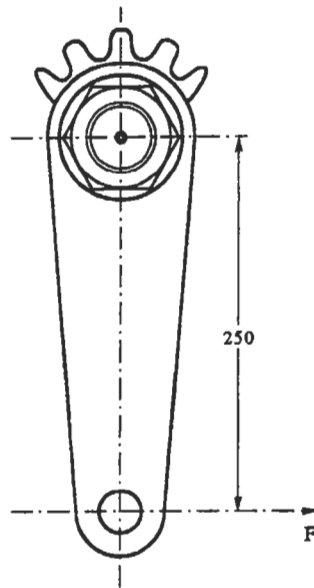
Fig. 2. End view of the steering shaft. Dimensions in mm.

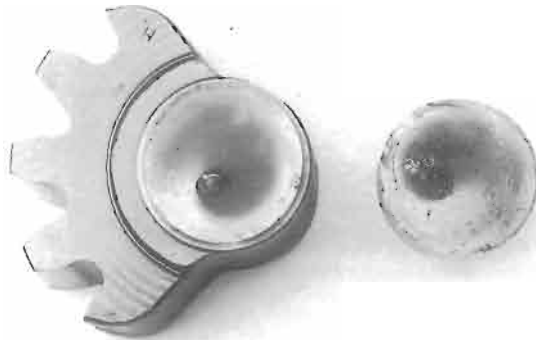
Fig. 5. Photograph of the matching fracture surfaces.

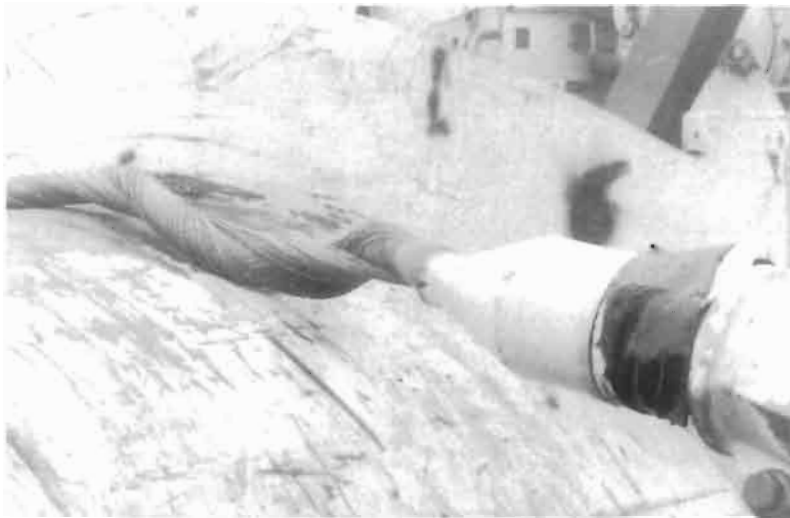
Fig. 8. Characteristic damage induced in spiral strand by pulling out a hockle or kink.

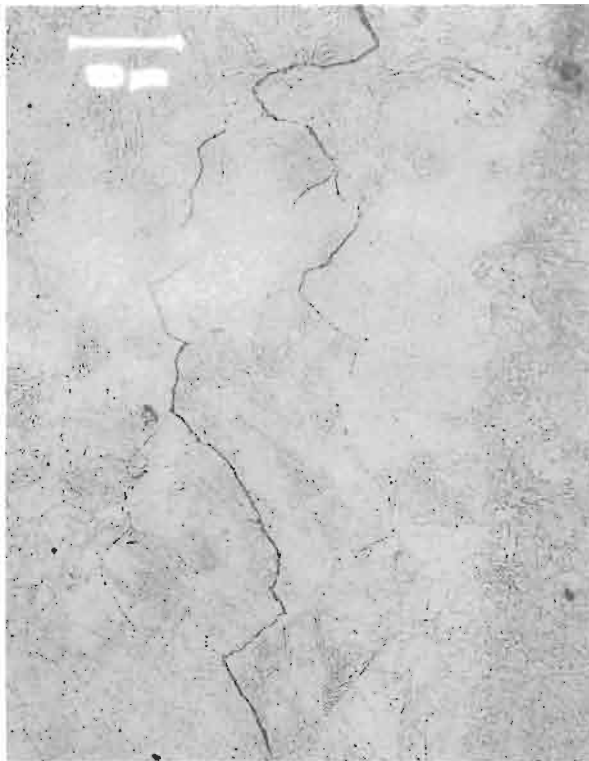
Fig. 5. Cracking on the 8 in. line side of the Y-side connection to the steam chest. The darker band to the right is weld metal. (Photomicrograph taken from a replica made in the cavity produced by removing a boat sample.) (Nital etch, bright field, cellulose acetate replica.)

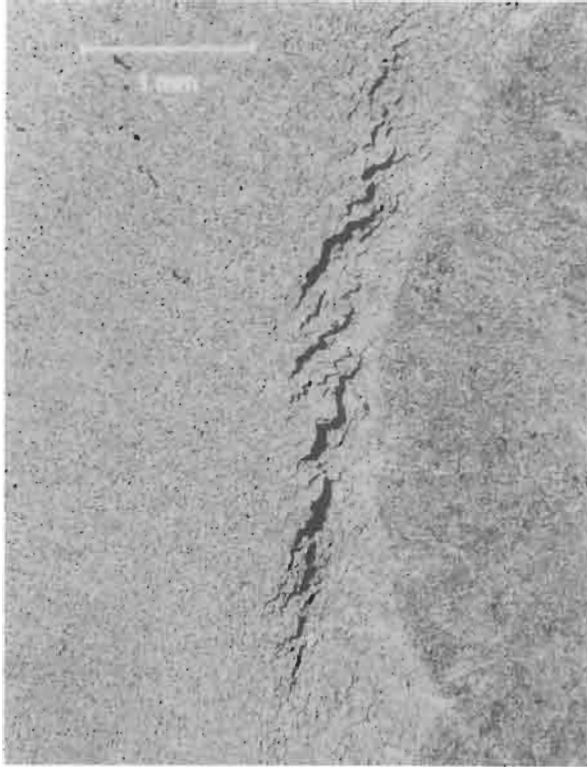
Fig. 7. One of the clusters of cracks in the HAZ on the reducer side of the weld joining the X-side reducer to the 8 in. pipe HAZ. The whole cluster is about 3.8 mm top to bottom.

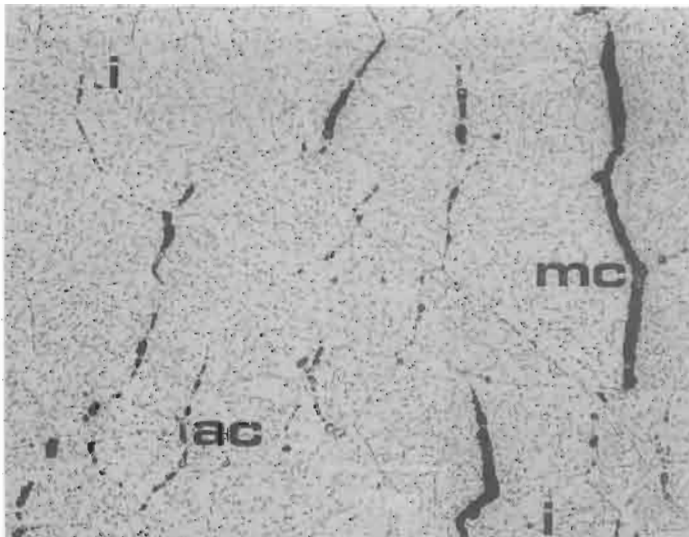
Fig. 8. This is close to one of the clusters of cracks in the reducer's HAZ. There are isolated grain boundary cavities, *i*, aligned groups of cavities, *iac*, and microcracks produced by the coalescence of aligned groups, *mc*. These are three stages in the progressive generation of creep cracks. (As in Figs 5-7, this is a coarse-grained region of the HAZ.) (Nital etch, bright field.)

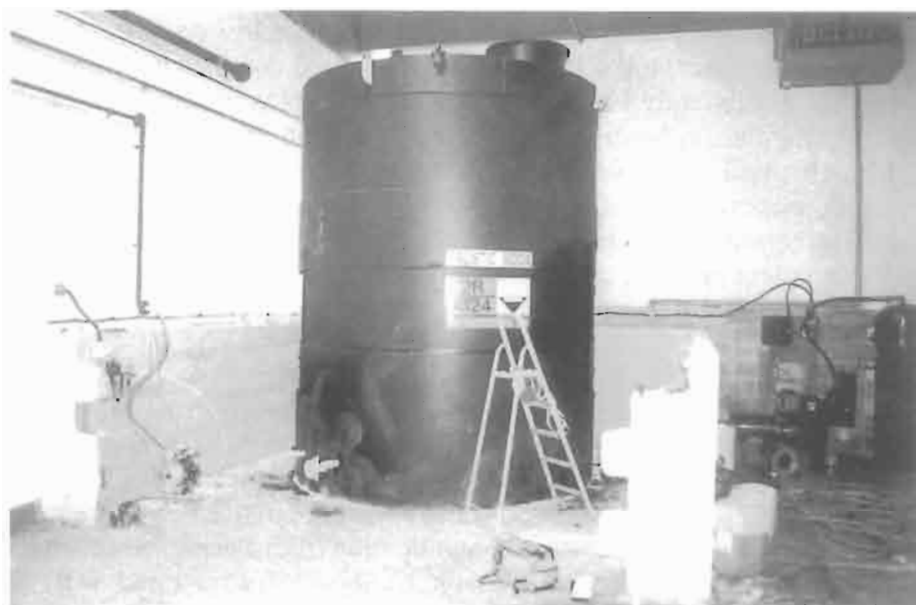
Fig. 2. Failed plastic tank, showing the bund wall in section (the front part was removed by the Fire Brigade). The jet of caustic soda flew from the tank wall near the right-hand edge in the figure, just above the top of the bund wall. It rose upward from a small crack in the weld, and landed some 4–5 m away from the exit point.

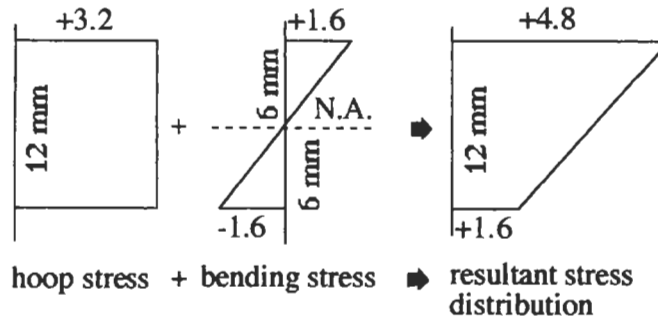
Fig. 7. Schematic addition of stress distributions through the thickness of the tank wall (stresses are shown in MN m^{-2} ; tensile stresses are taken to be positive).

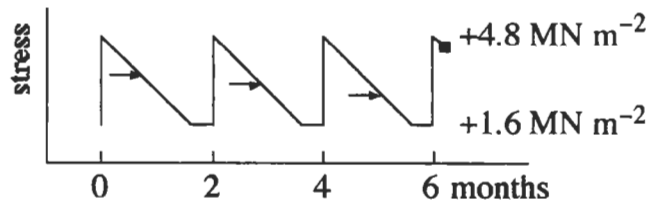
Fig. 8. Schematic of stress variation at outer surface in response to filling cycles of the tank: the arrows indicate schematically the critical stress for slow crack growth.

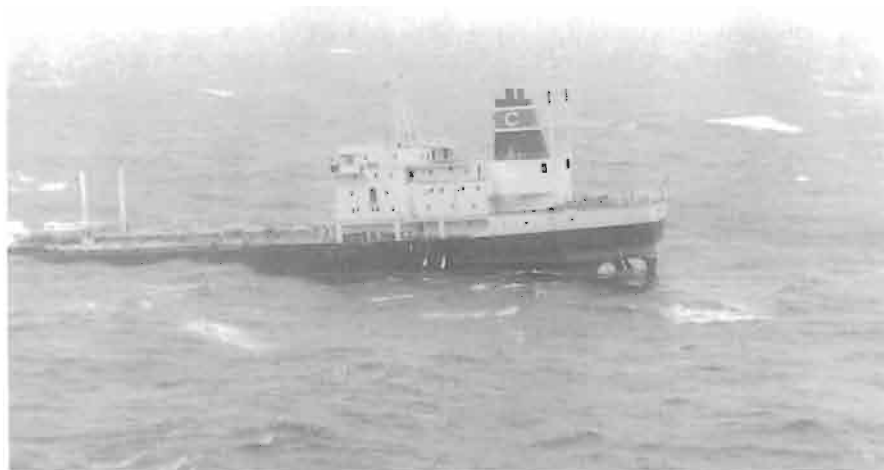
Fig. 4. Stern section of MV *Kurdistan* after breaking in two.

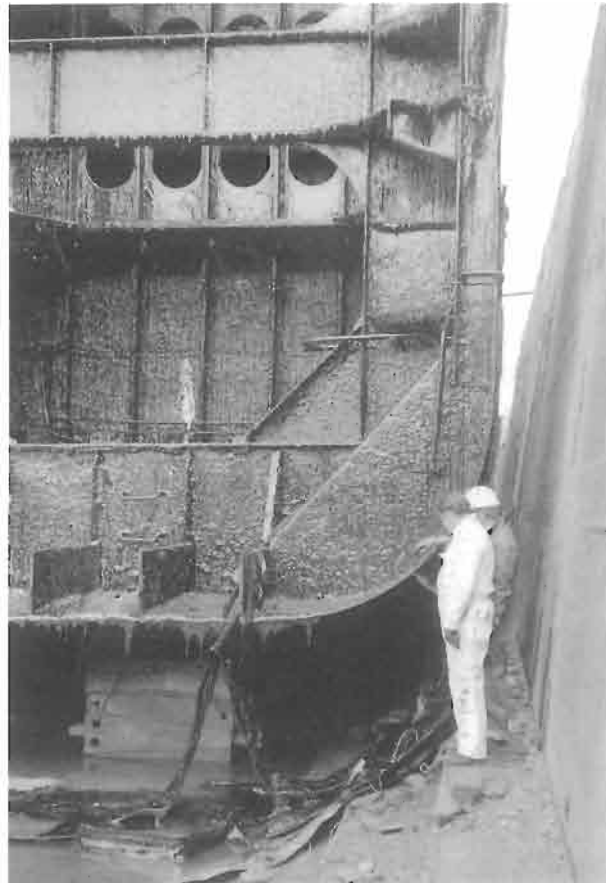
Fig. 8. Port bilge keel and keel showing three longitudinals, bilge bracket and fracture face of hull plating.

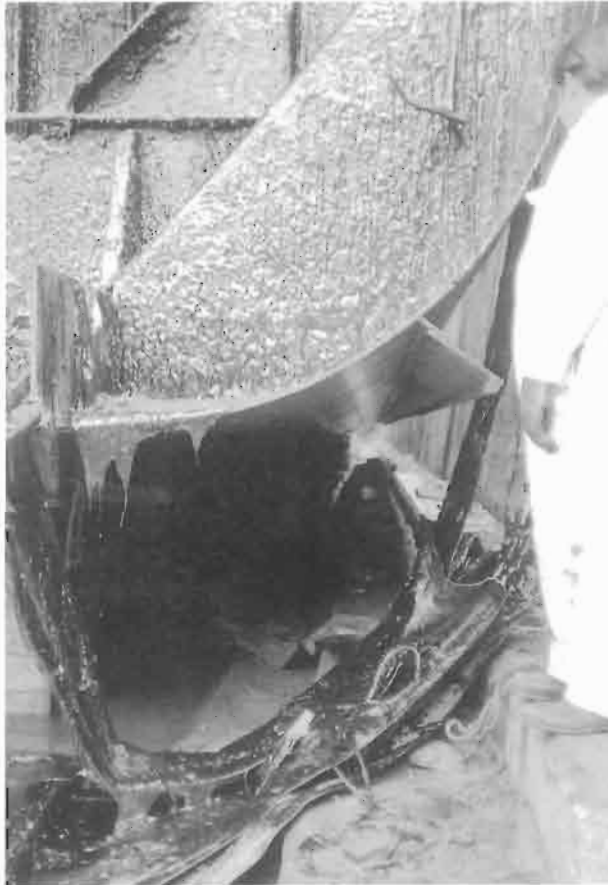
Fig. 9. Port bilge keel showing bilge bracket: also showing longitudinal.

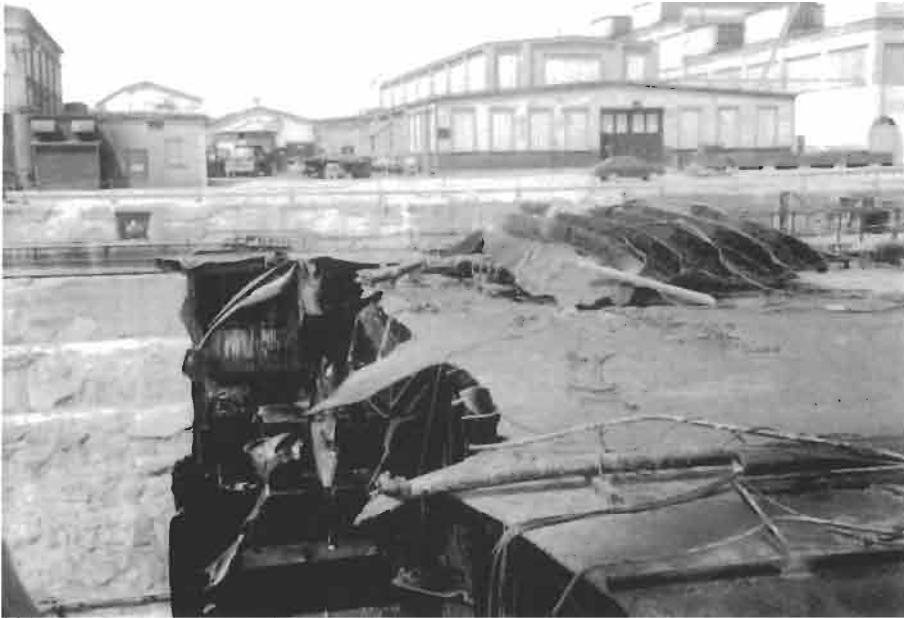
Fig. 12. View of the deck plate fracture: part of the deck and longitudinal ripped out during final fracture is also shown.

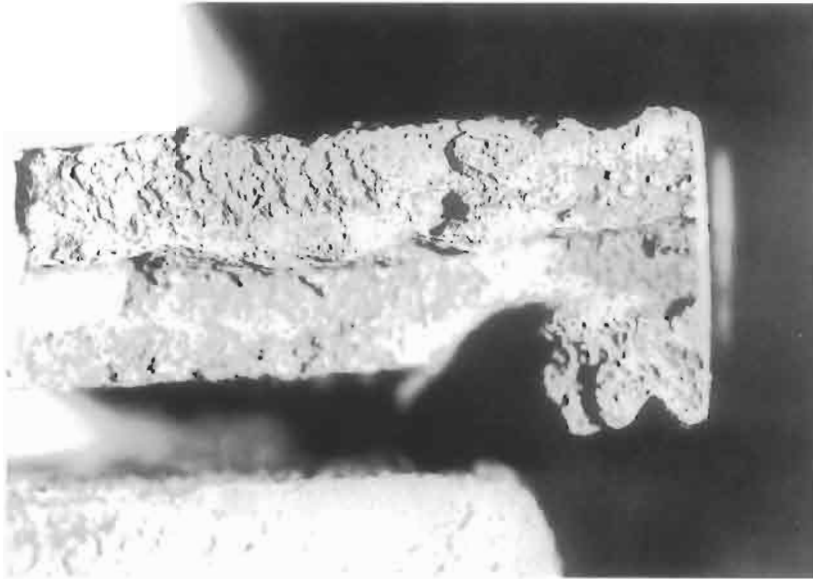
Fig. 18. Fracture surface of ground bar butt weld in sample 1 in single-sided region, close to inboard edge of bulb bar. Note smooth, featureless region in root of weld. $\times 4$.

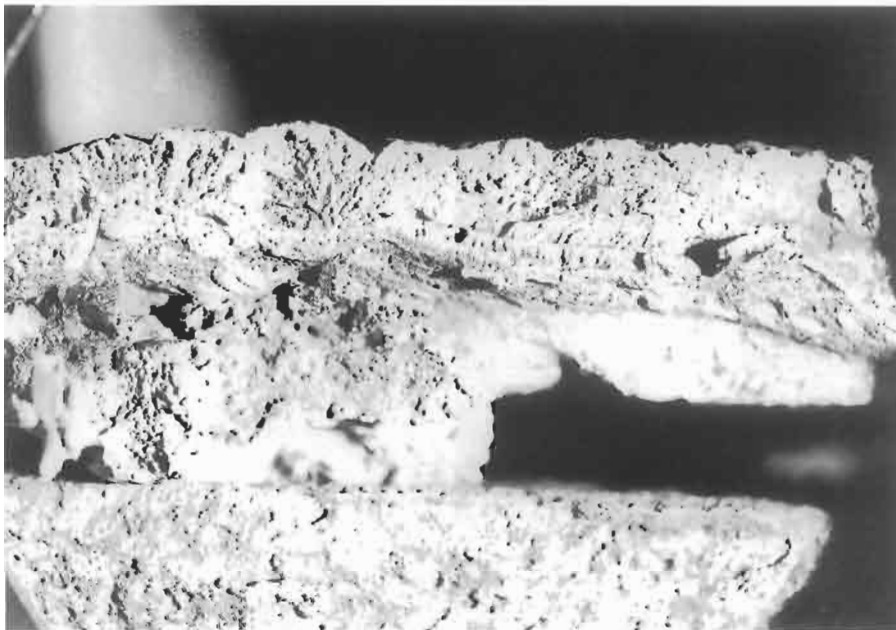
Fig. 19. Fracture surface of ground bar butt weld in sample 1 in single-sided region, close to outboard edge of ground bar. Note smoother fracture surface in weld root, from which some chevron patterns (arrowed) emerge. $\times 4$.

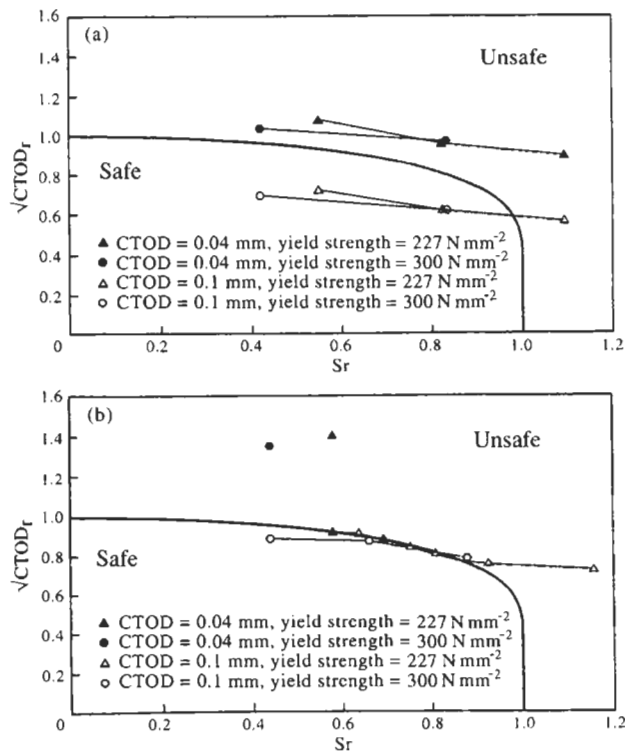
Fig. 26. (a) MV *Kurdistan* level 2 assessments—embedded defect assumption. (b) MV *Kurdistan* level 2 assessments—surface defect assumption.

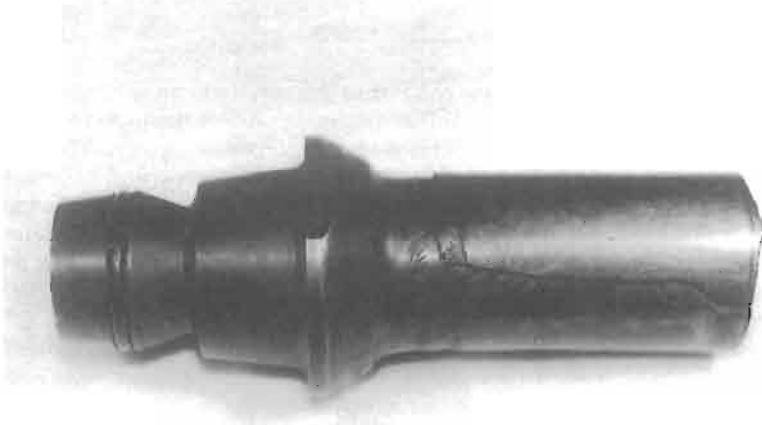
Fig. 1. Typical failed actuator piston rod showing the adapter, the circumferential weld and a large crack.

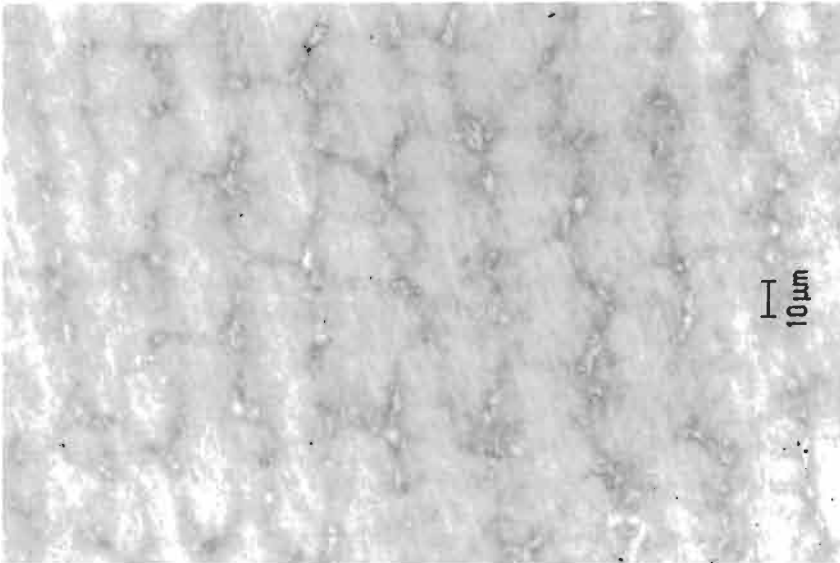
Fig. 4. Optical micrograph of one of the E312 welds showing severe carbide precipitation (etchant: Beraha's tint etch).

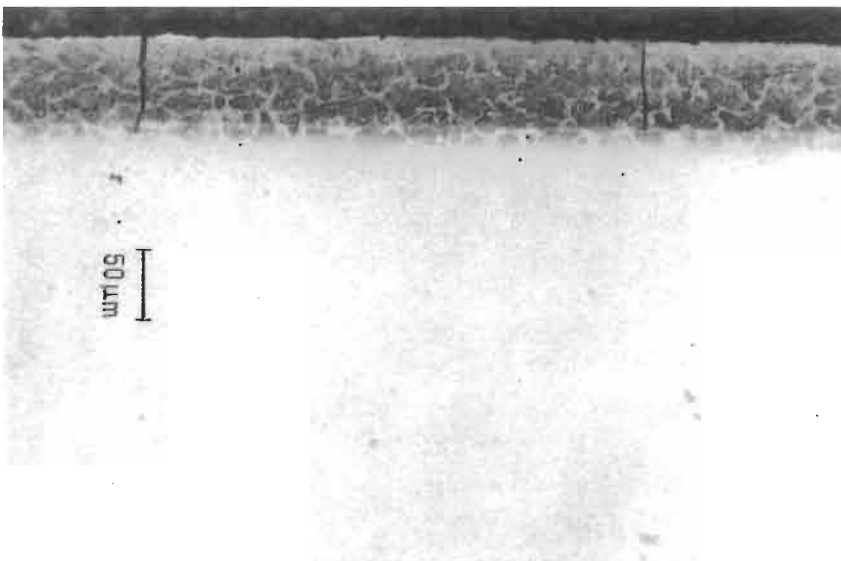
Fig. 5. Optical micrograph of the E312 weld showing cracks that originated after the nitriding (etchant: 2% Nital).

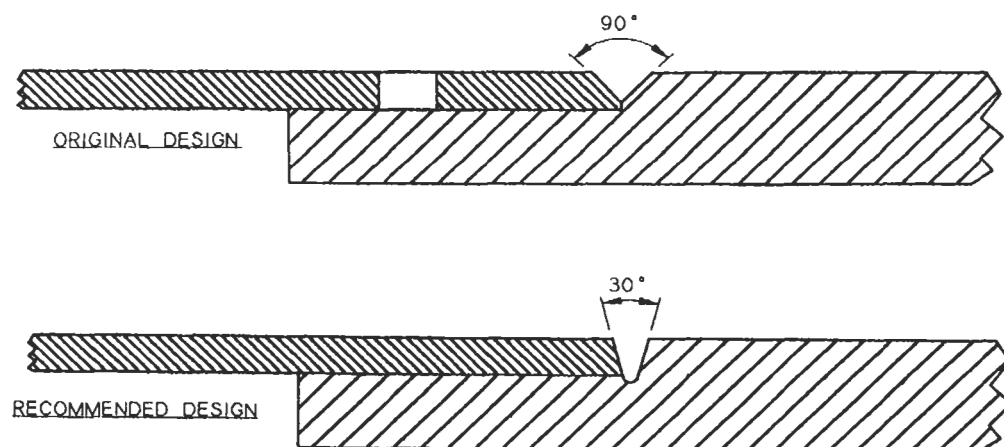
Fig. 8. Schematic drawings of the original and recommended weld preparations.

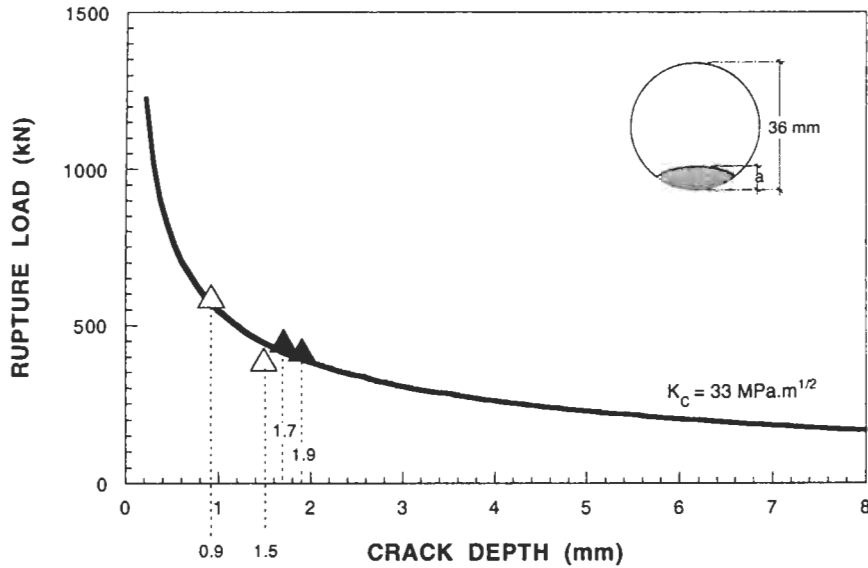
Fig. 6. Rupture load of a cracked bar as a function of crack depth (for $D = 36$ mm and $K_{IC} = 33$ MPa m^{1/2}). (Δ), Actual cracks. (▲), Fatigue cracks (laboratory).

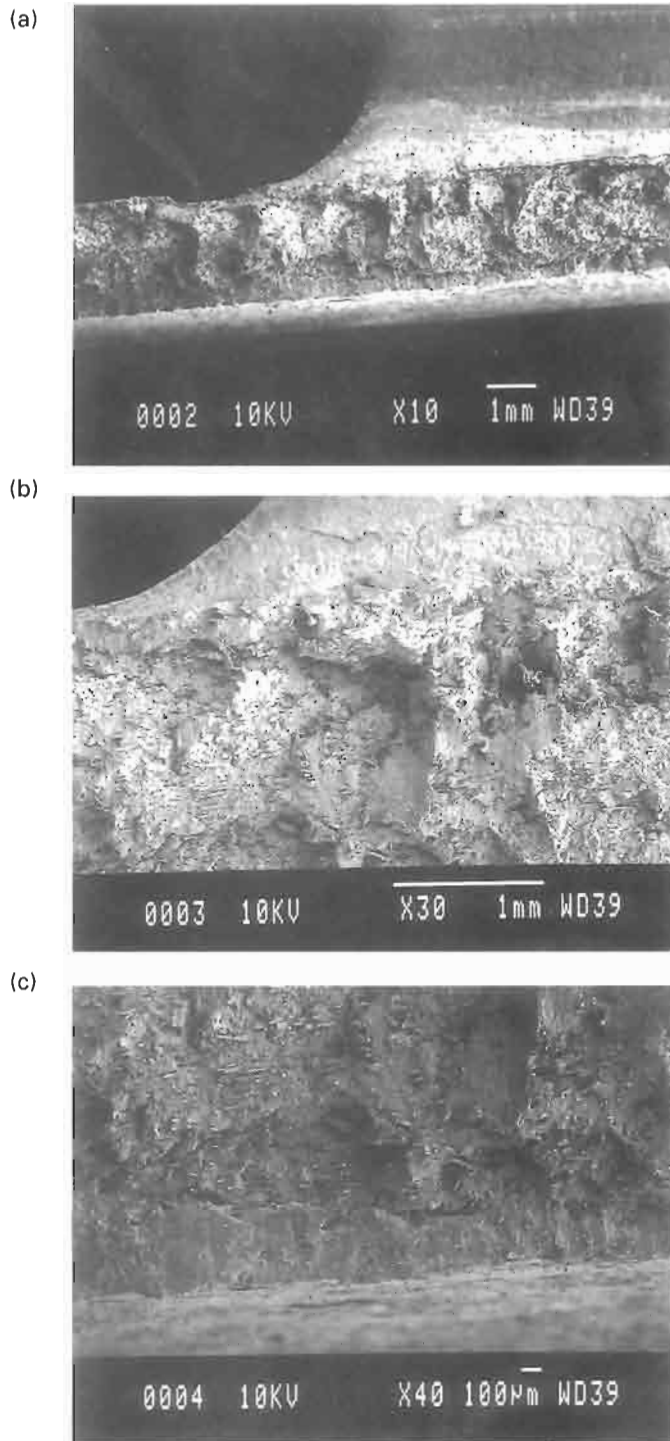
Fig. 11. Various SEM shots of fracture surface.

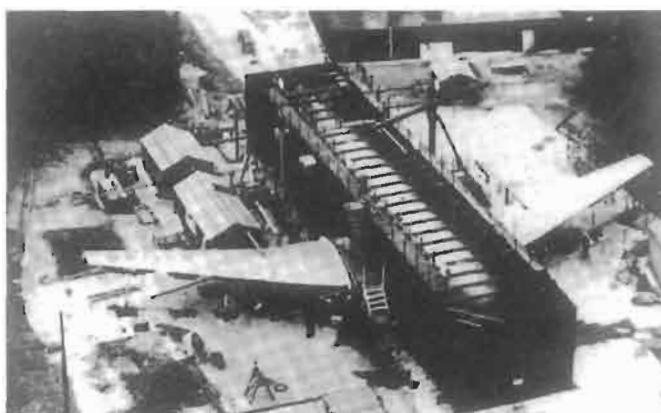
Fig. 2. Aerial view of Comet G-ALYU in testing tank. Crown Copyright. Reproduced with the permission of the Controller of HMSO.

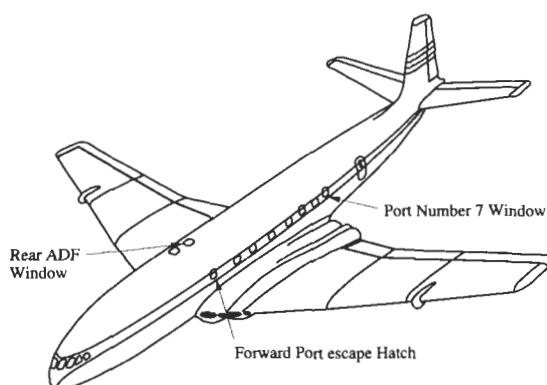
Fig. 3. The main failure sites on Comets G-ALYP and G-ALYU.

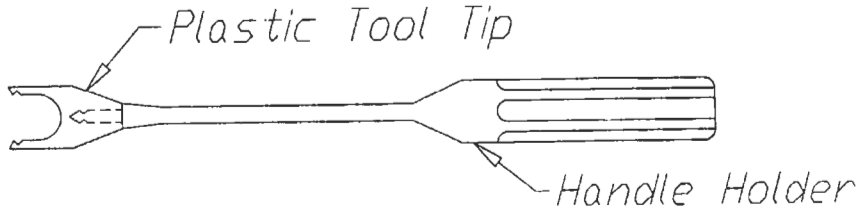
Fig. 1. Schematic of a handle holder titanium 6Al-4V heart valve surgery tool.

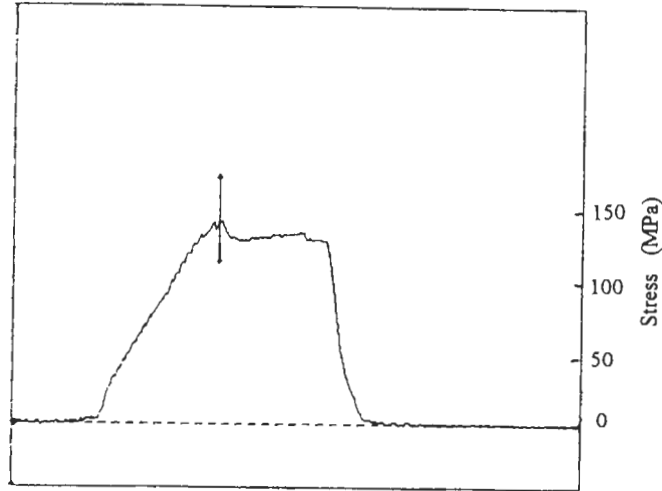
Fig. 7. Strain time trace in the bending configuration under so called "stall" conditions, with the disc brake completely removed. Far from exhibiting minimal stresses the trace shows substantial offset bending strains imposed through the Belvel washers and recessed nut assembly.

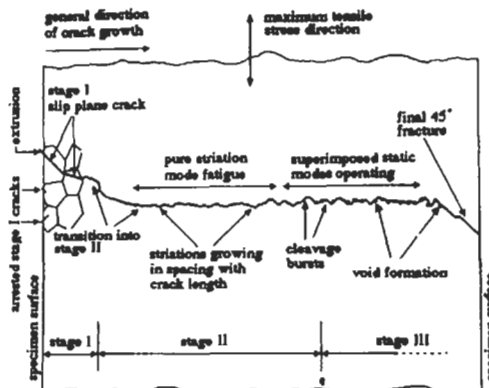
Fig. 10. Schematic diagram showing the nature of crack growth behaviour.

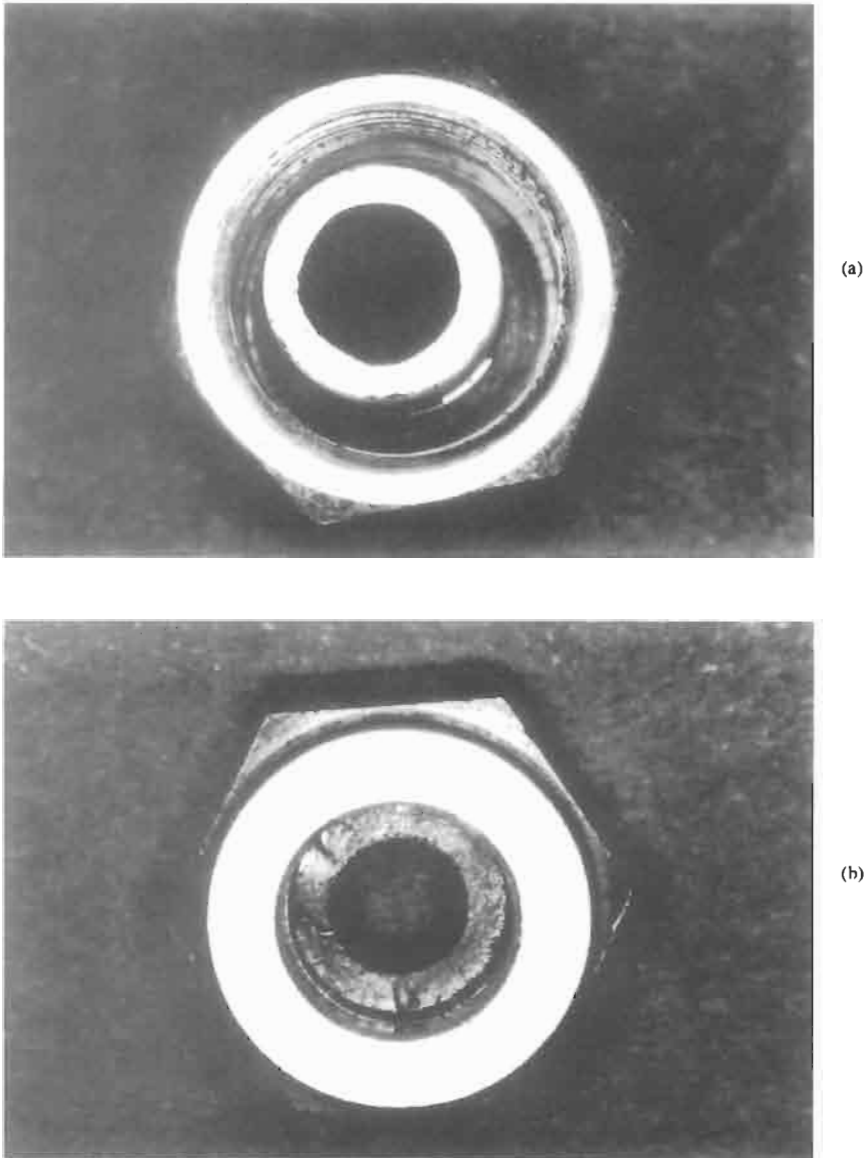
Fig. 3. End connector with the fractured piece jammed inside the nut.

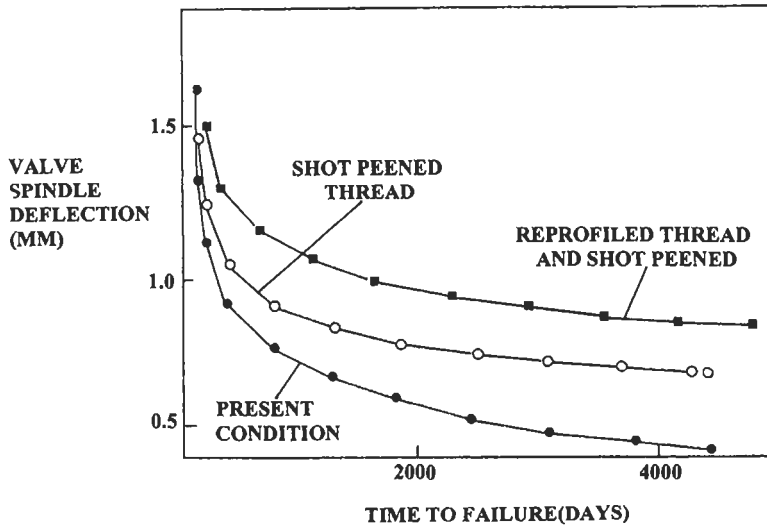
Fig. 7. Time to fatigue failure versus spindle deflection.

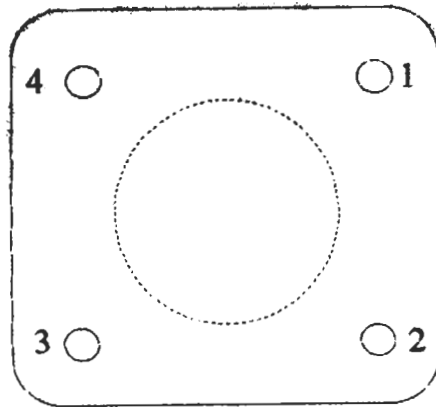
Fig. 1. Schematic of hold-down and bolts (numbered 1–4).

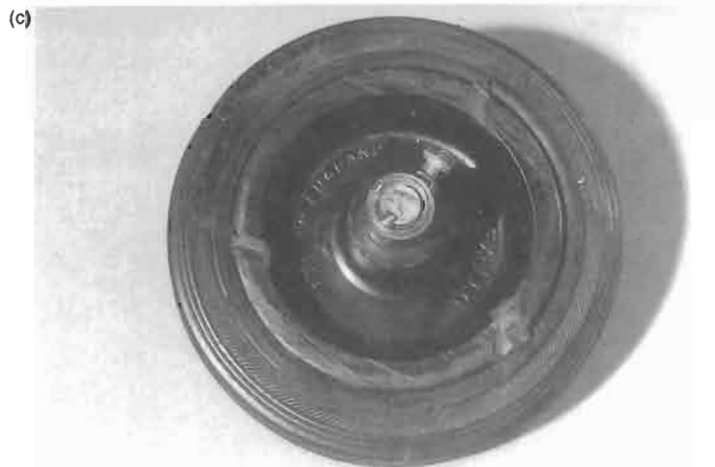
Fig. 3. The failed wheel shaft. (a) and (b) close examination of fracture; (c) failed hub portion and wheel.

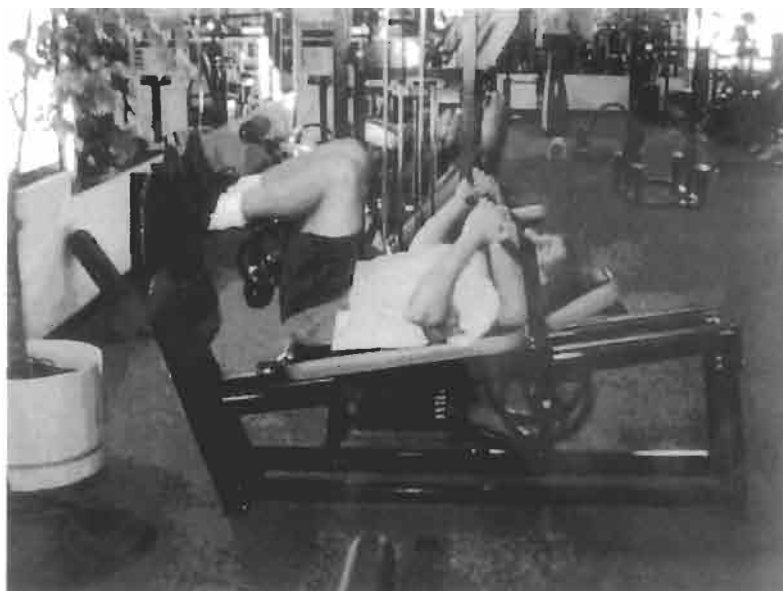
Fig. 1. Person performing a leg press.

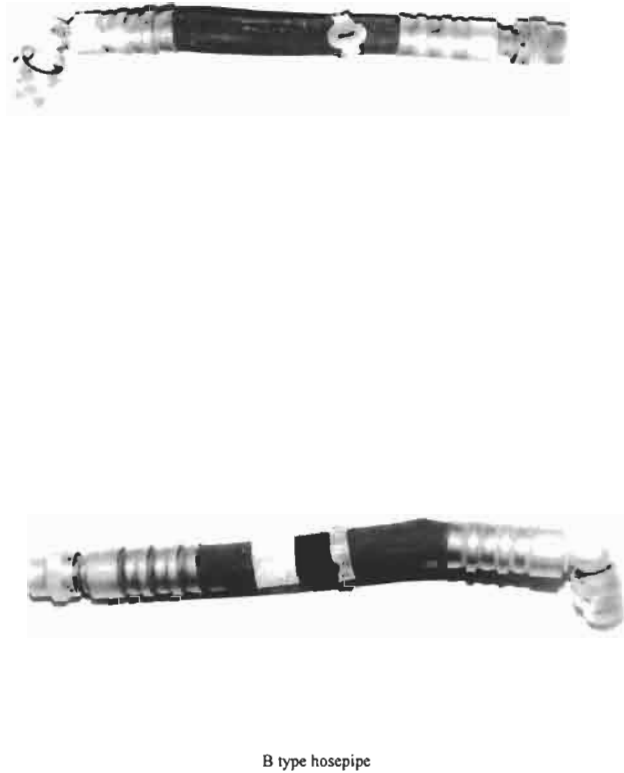
Fig. 1. Appearance of bursting hosepipes (arrowheads aim at openings).

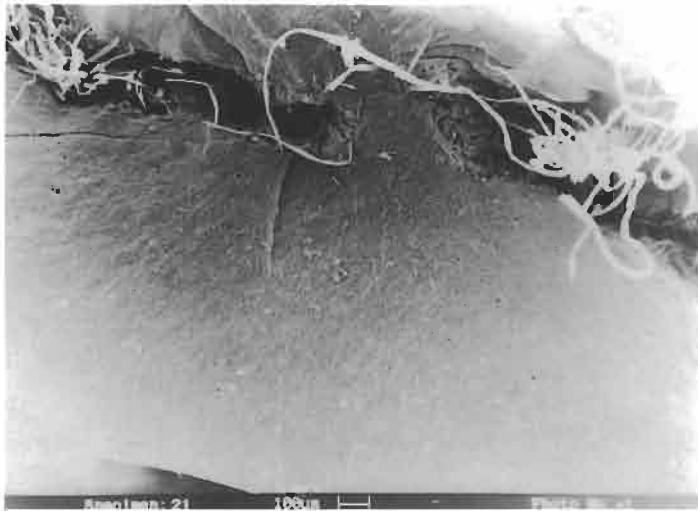
Fig. 5. The fracture appearance of a B type hosepipe.

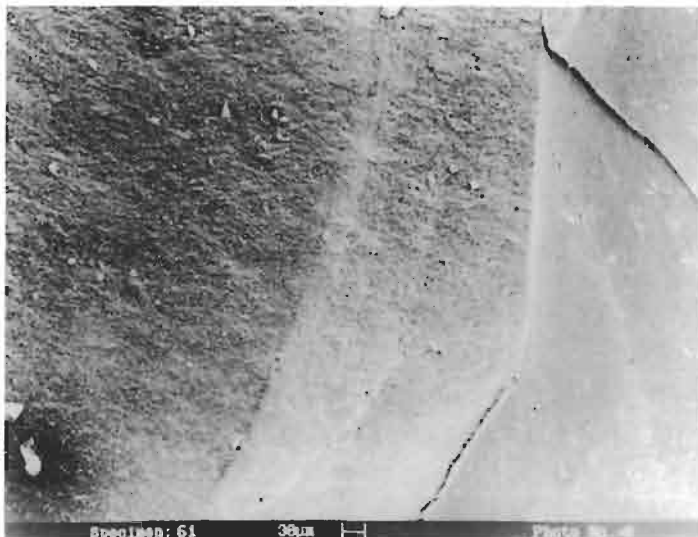
Fig. 6. Fatigue beach marks.

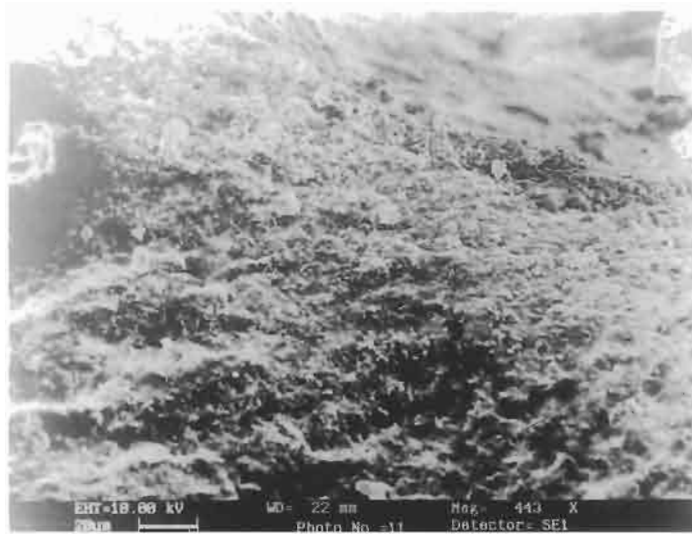
Fig. 7. The fracture appearance of small cracks.

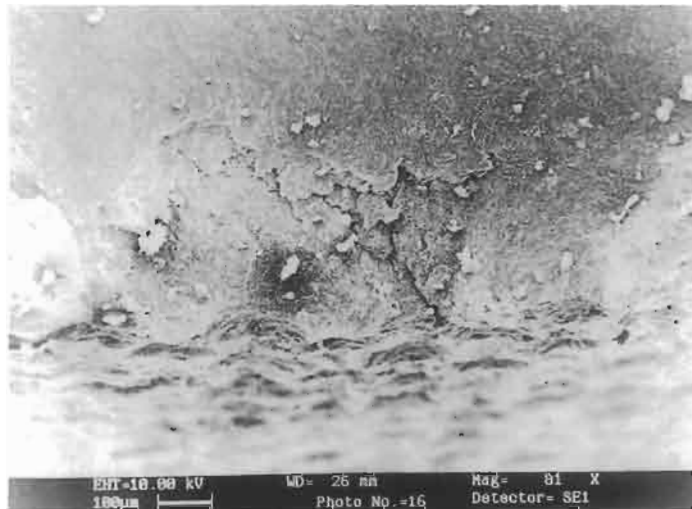
Fig. 8. The fracture appearance of the outer layer.

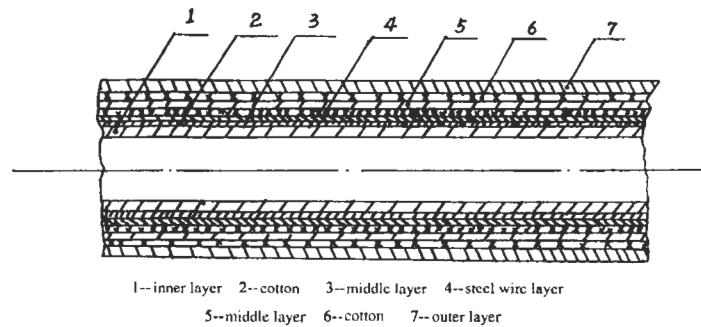
Fig. 9. Sectional diagram of the bursting hosepipe structure.

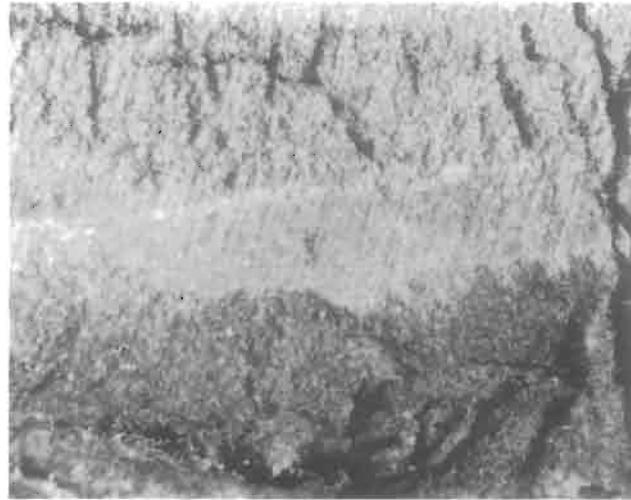
Fig. 5. Stereomicrograph of the cracked portion of the sight port flange. × 16

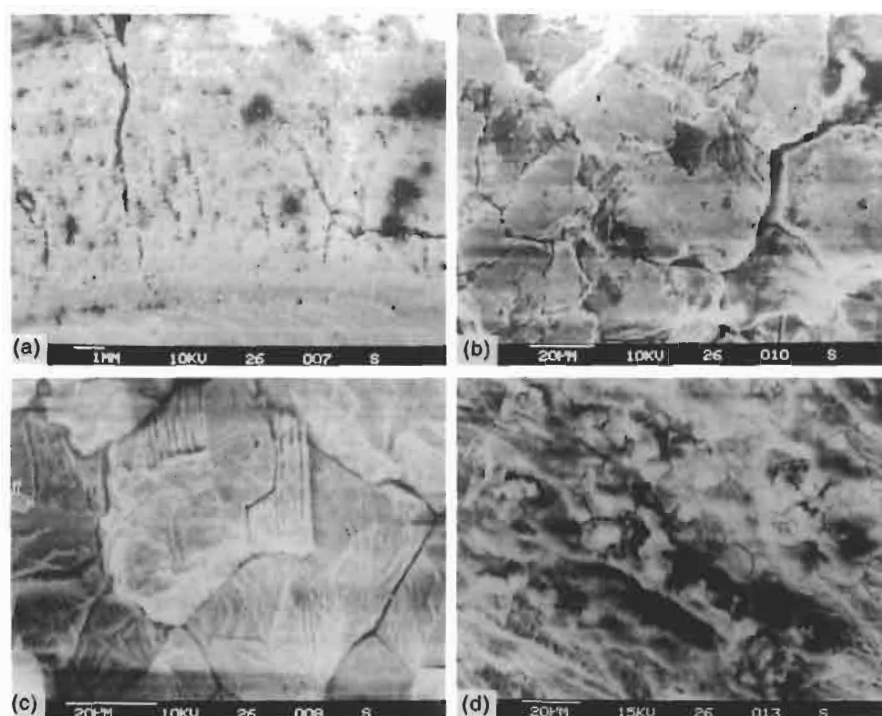
Fig. 8. SEM fractographs of failed sight port flange. (a) Radial cracks starting from the pipe-to-flange interface. (b) Intergranular cracks with grain dissolution. (c) Intergranular cracks with preferential attack along slip bands. (d) Corrosion product (Fe_2O_3).

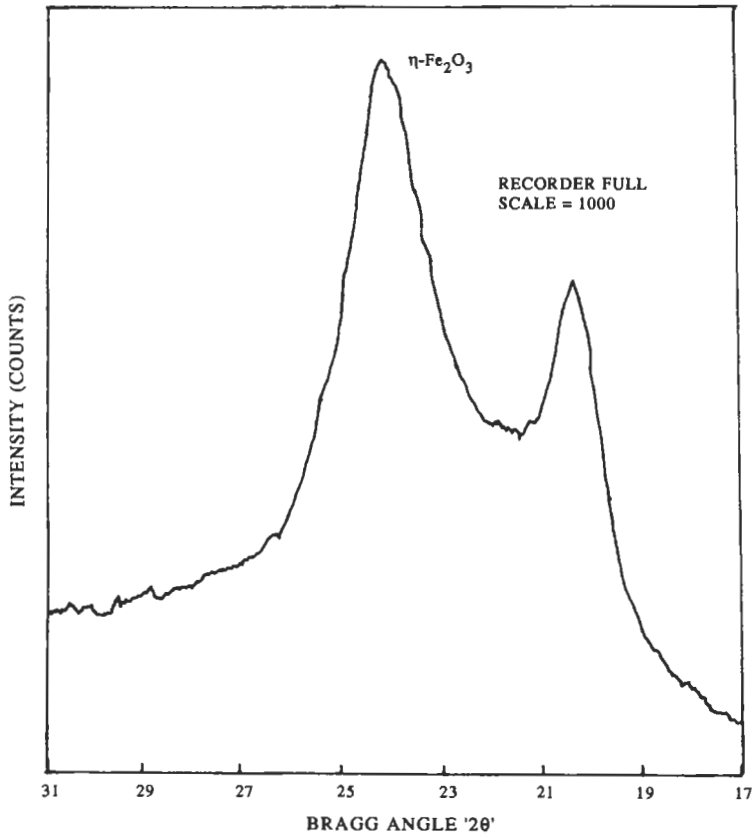
Fig. 9. XRD pattern of corrosion product (Fe_2O_3) on sight port flange.

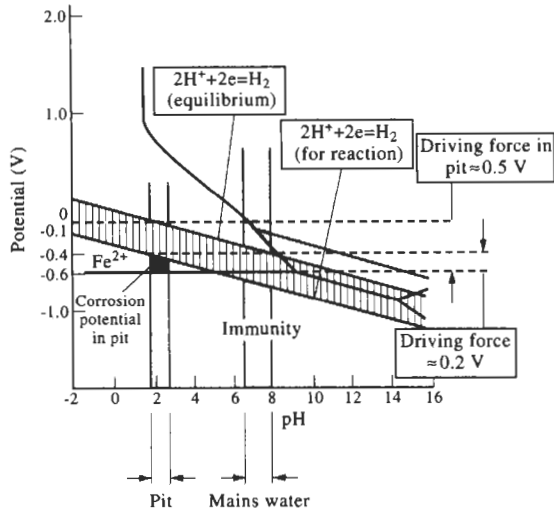
Fig. 7. The Pourbaix diagram for iron at 25 °C, showing the hydrogen-reduction reaction.

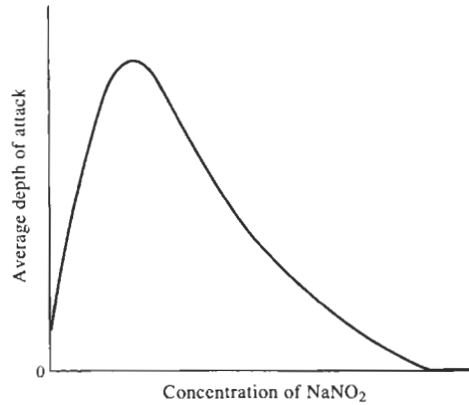
Fig. 9. Schematic effect of sodium nitrite concentration on the rate of corrosion of mild steel in mains water.

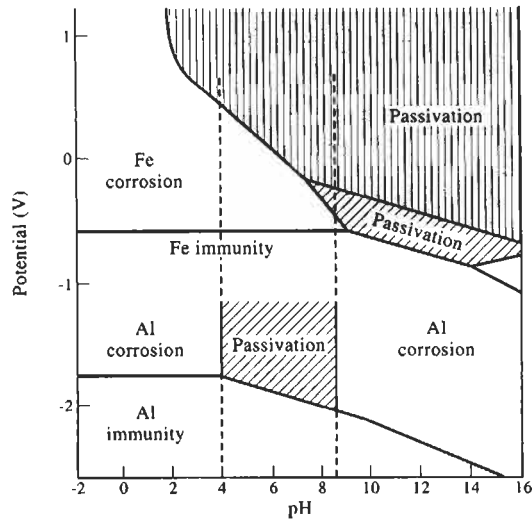
Fig. 13. Superposition of the Pourbaix diagrams for iron and aluminium at 25°C.

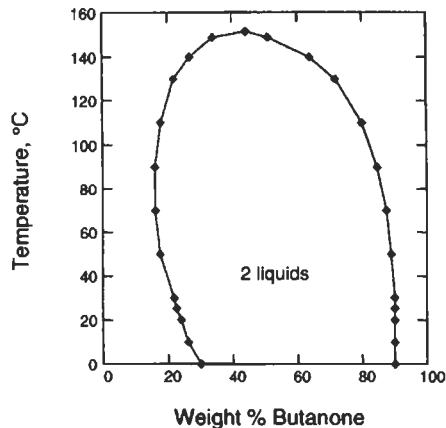
Fig. 1. Water–butanone phase diagram showing single-liquid phases for water- and butanone-rich solutions separated by a two-phase region of liquid immiscibility.

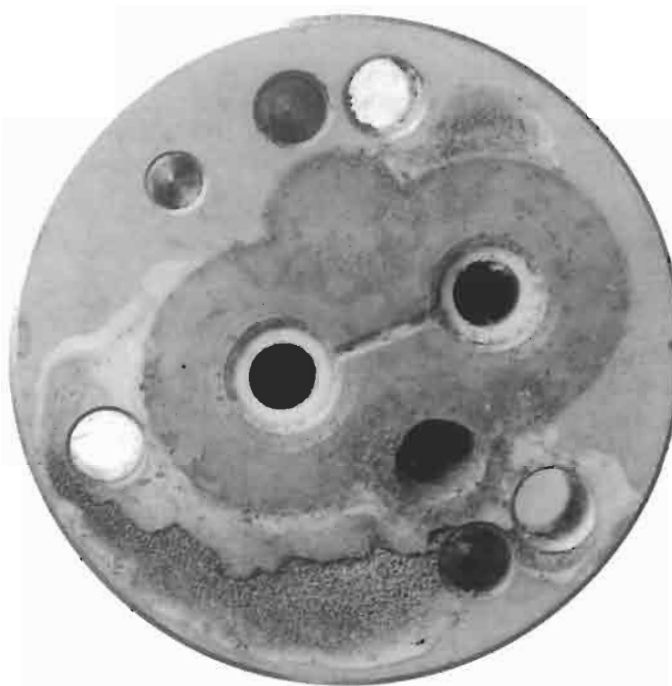
Fig. 2. Crevice corrosion suffered by the 316L stainless steel pump. Small crystals of sodium chloride can be seen on and around the corroded area.

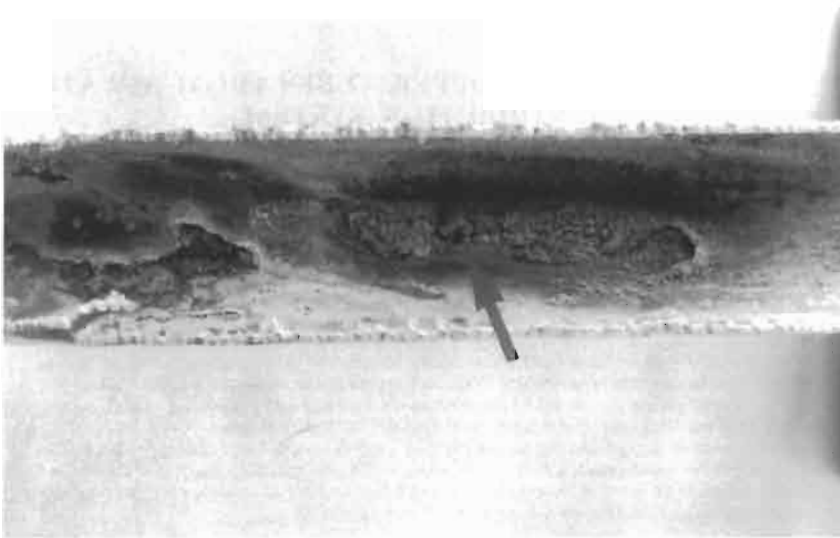
Fig. 1. The internal surface of a tube ($\times 2$). The arrow indicates the presence of a tubercle of corrosion product.

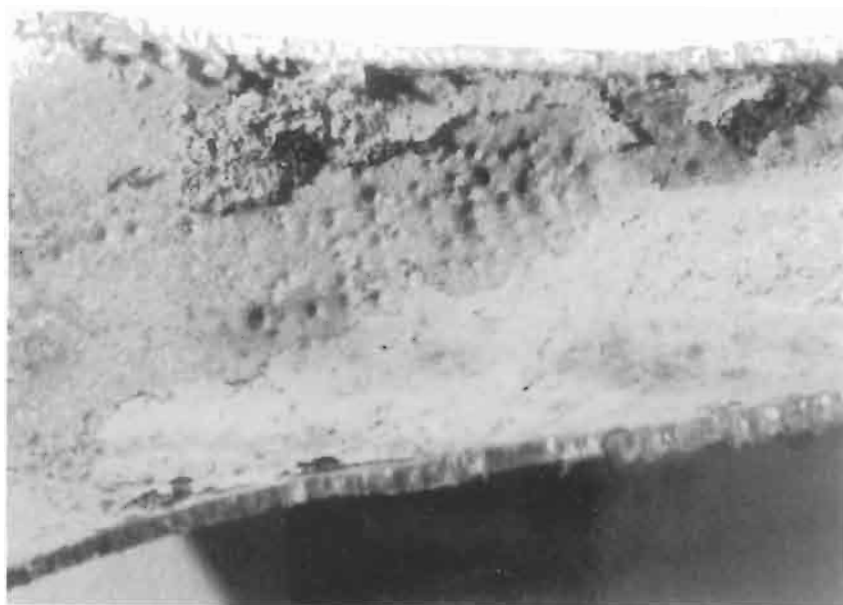
Fig. 3. The internal surface of a tube showing extensive pitting ($\times 3$).

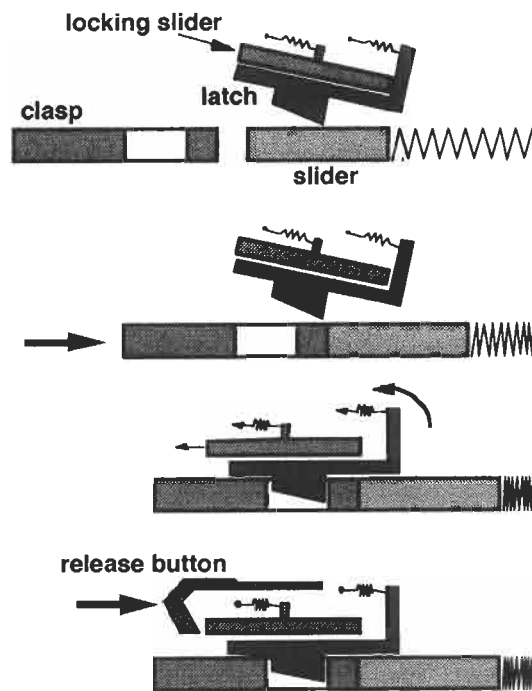
Fig. 2. Schematic side view of the seat belt latching mechanism showing the interactions among the main components, including the release button (bottom).

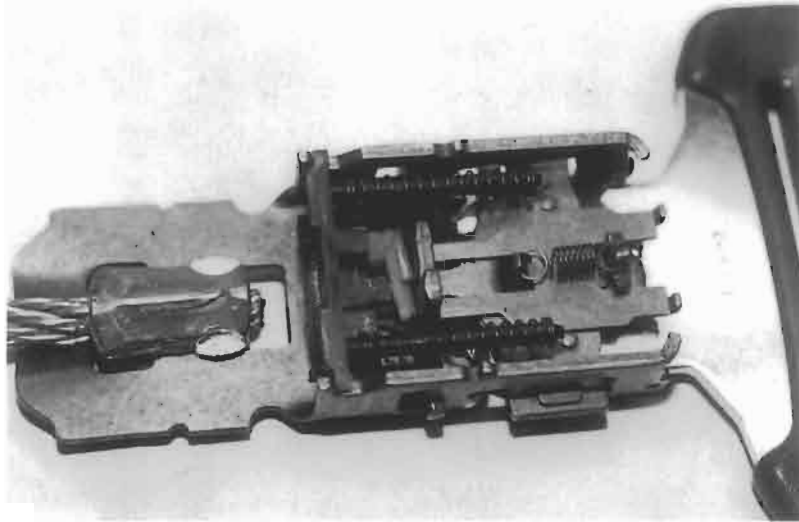
Fig. 6. 'Mode two' failure, showing a fragment of the release button lodged just to the left of the locking slider. In this case, the fragment keeps the locking slider from sliding to the unlocked position when the release button (not shown) is pressed.

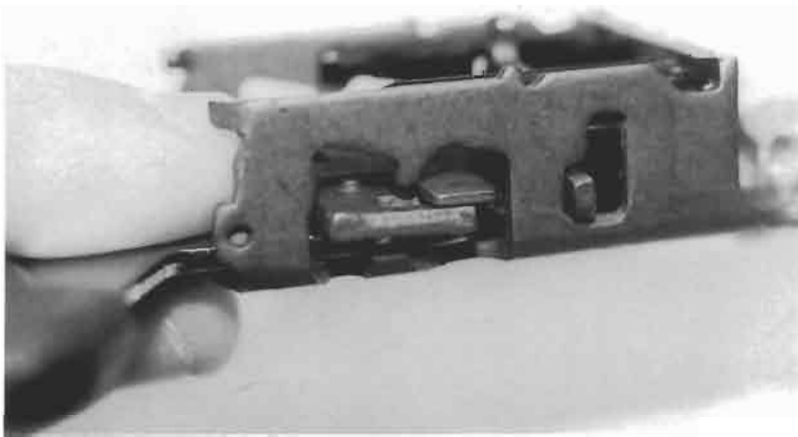
Fig. 7. 'Mode three' failure. In this case the button fragment (not shown) does not allow the locking slider to slide all the way to the latched position (compare to Fig. 3) giving the appearance that the buckle is latched when it is not.
