***FAILURE
ANALYSIS
CASE
STUDIES II***

Edited by
D.R.H. Jones

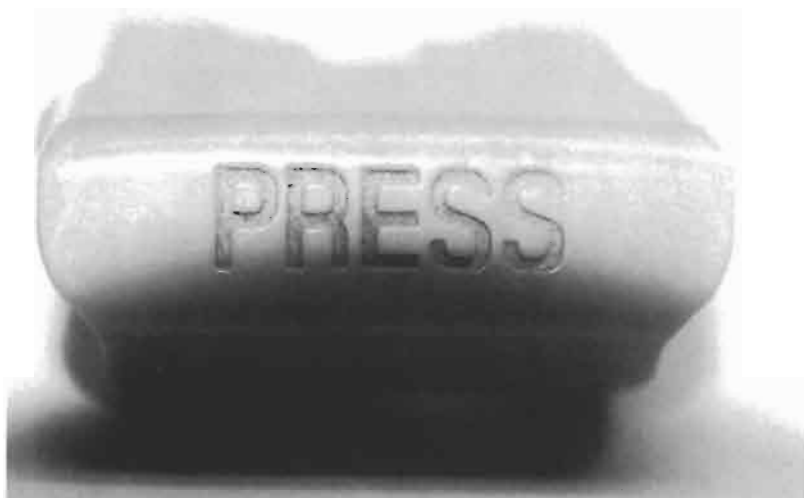
Fig. 11. 'Press' surface of release button showing discoloration and crazing.

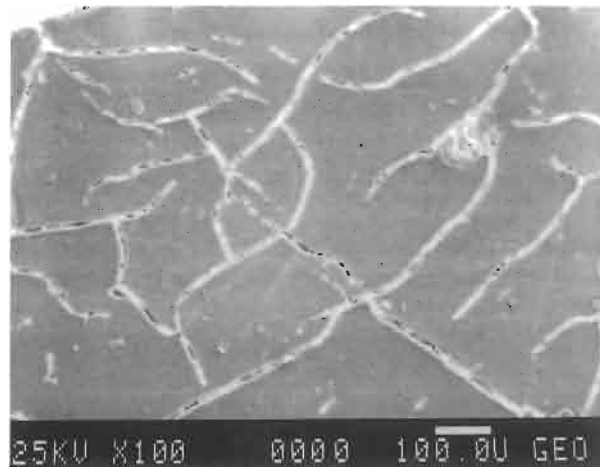
Fig. 13. Scanning electron micrograph of the button in Fig. 12. The crazing cracks are seen to extend through the surface of the material.

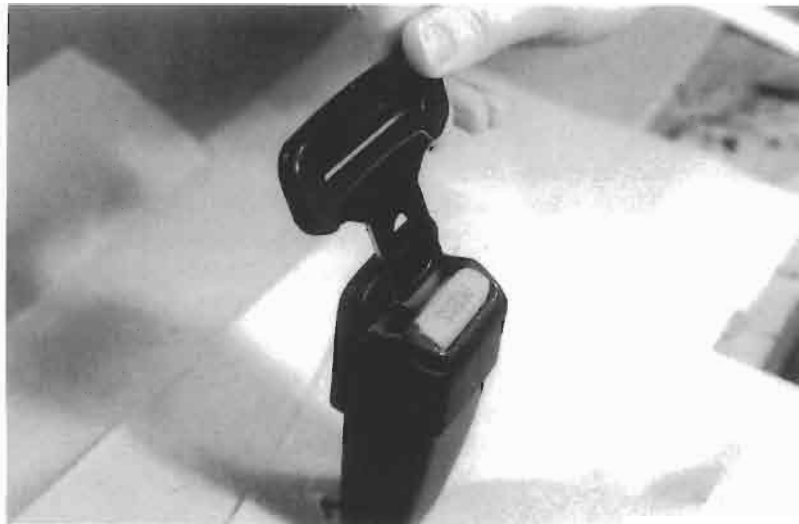
Fig. 14. Short-term solution to the seat belt failure problem. The plastic guard installed on the seat belt receptacle is intended to reduce impact damage to the release button.

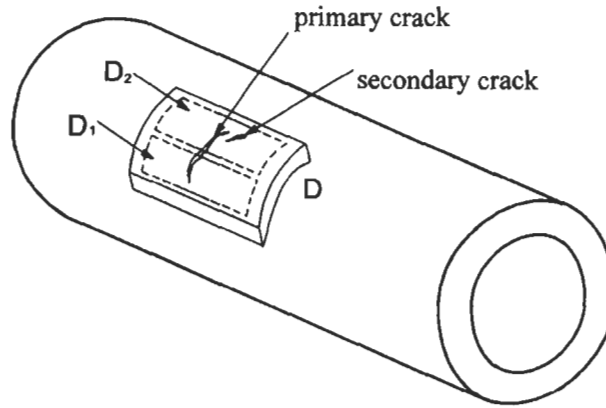
Fig. 2. Samples of a cracked radiant tube for failure analysis.

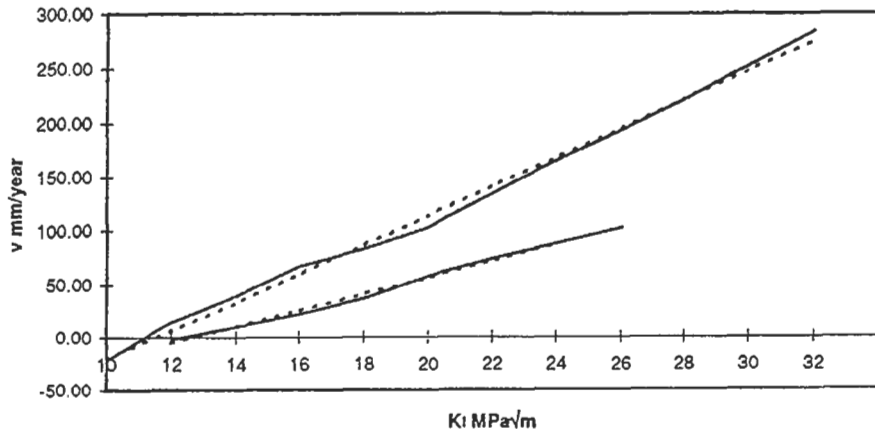
Fig. 4. Data from Lewandowski *et al.* [2] for crack growth at 30°C (solid lines). The upper data is for 100 ppm Pb and the lower data is for 30 ppm. The data appear to obey a linear relationship (dashed lines). A linear relationship implies there is a threshold below which no growth occurs.

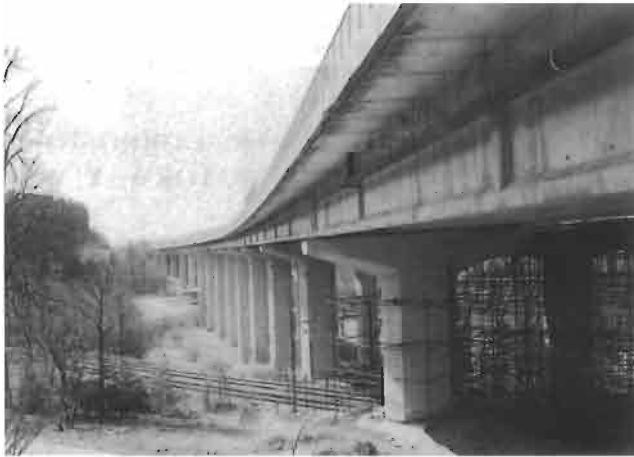
Fig. 1. Prestressed concrete construction of the viaduct.

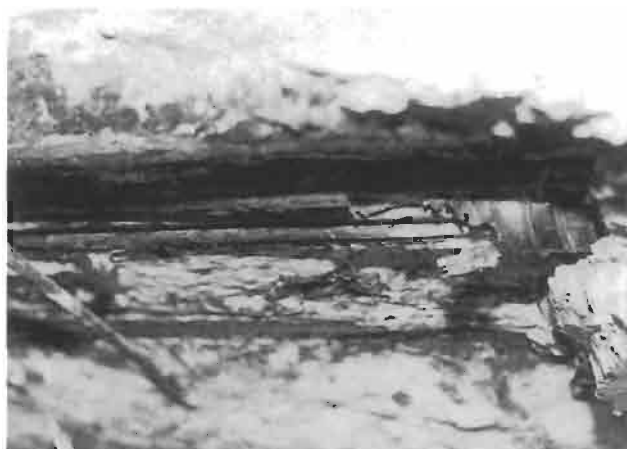
Fig. 3. Corrosion damage of cables.

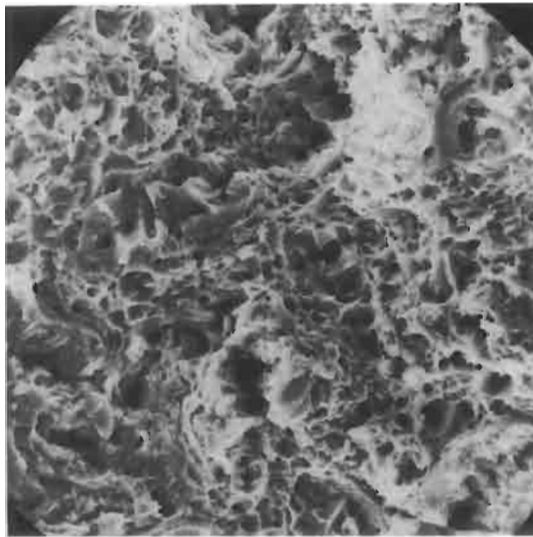
Fig. 5. SEM photograph of a specimen with Corr. d. = 0, showing the tough fibrous zone. $\times 2000$.

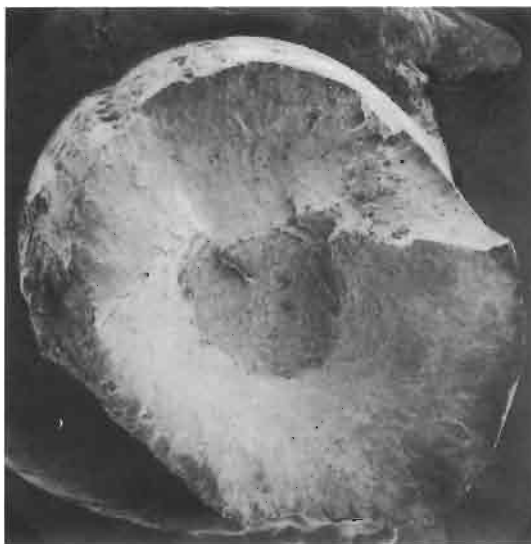
Fig. 6. SEM photograph of a specimen with Corr. d. = 2, with a reduced fibrous zone, and increased brittleness of the shear-lip zone. $\times 13$.

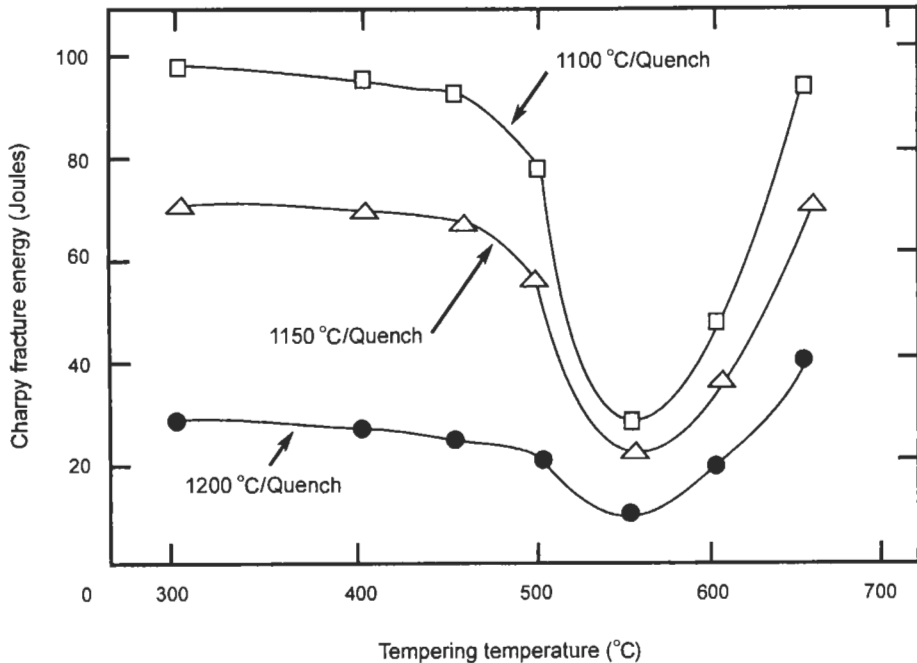
Fig. 6. Charpy impact toughness of either AISI 431 or En 57 as a function of tempering temperature, austenitized at various temperatures and oil quenched.

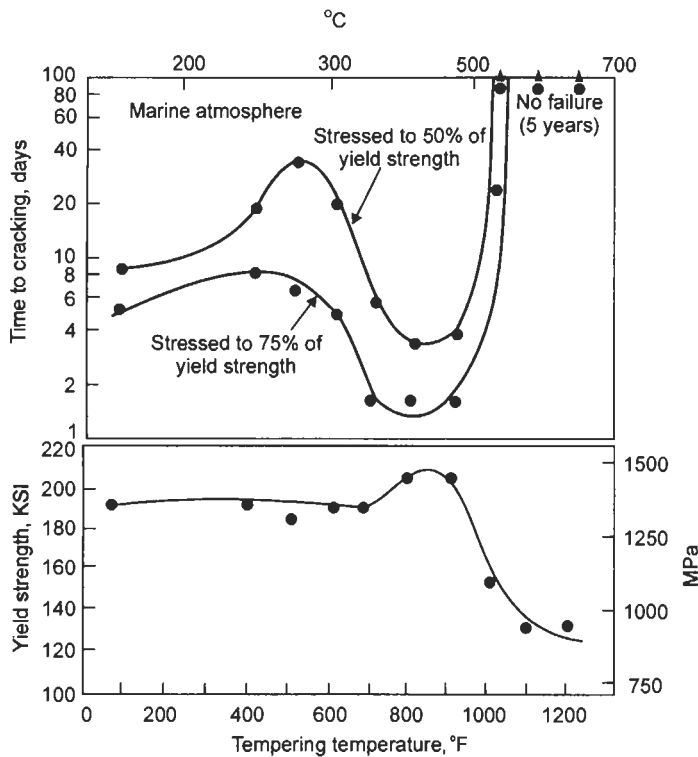
Fig. 7. Effect of tempering temperature on the cracking resistance and yield strength of martensitic stainless steel in a marine atmosphere.

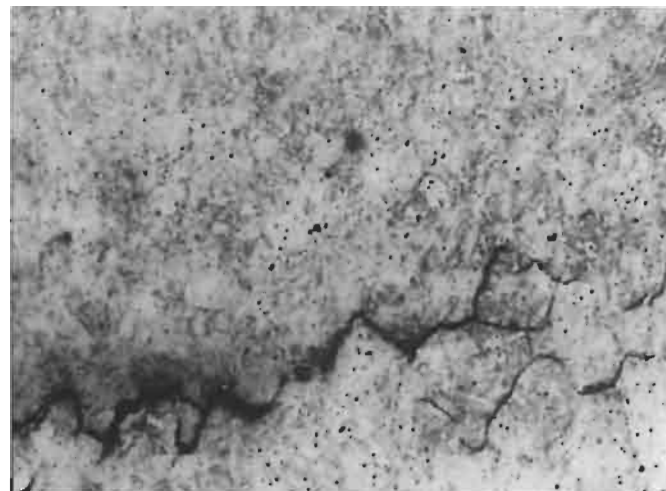
Fig. 3. Replicated micrograph of reheat crack showing bainitic microstructure and crack path following weld heat affected zone (magnification $\times 50$).

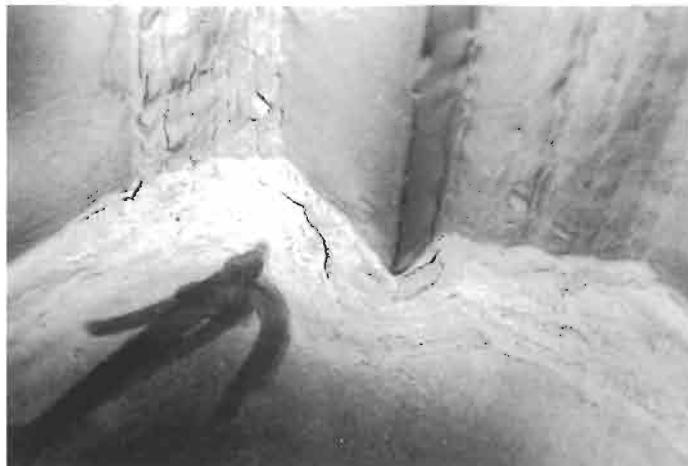
Fig. 4. Typical cracks found at external support welds.

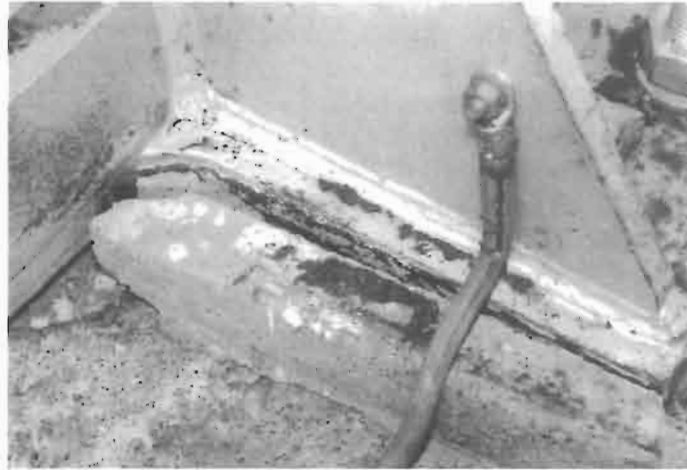
Fig. 7. Typical detail of gusset welds showing complete absence of “rat hole” at the junction of the three members.

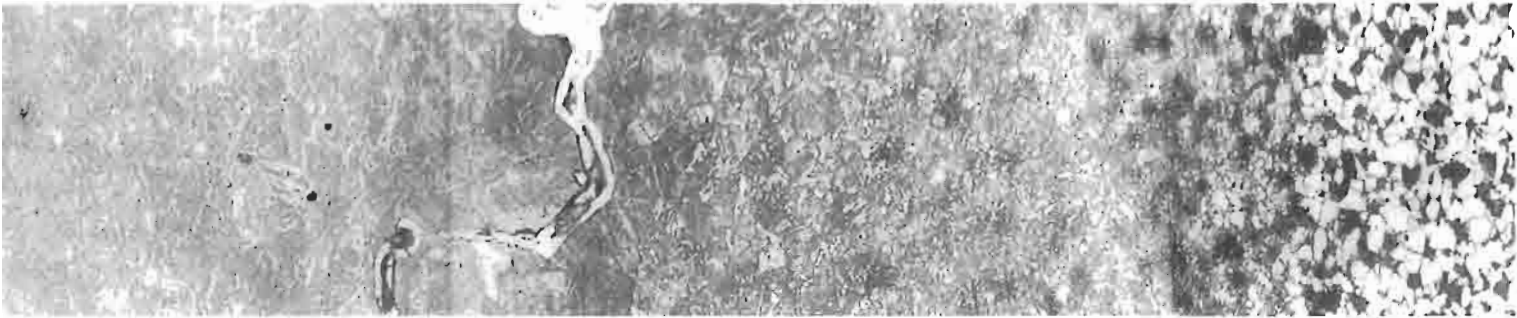
Fig. 9. "Panoramic" section of crack location in support G1 (magnification $\times 100$).

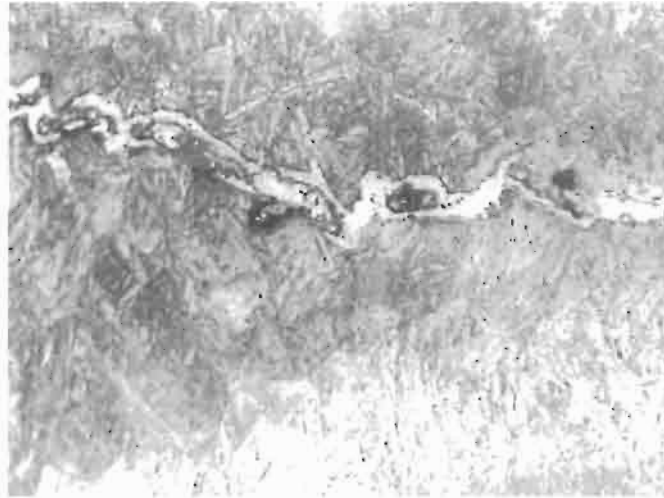
Fig. 10. Detail of oxide filled crack in martensite area of HAZ, support G1 (magnification $\times 100$).

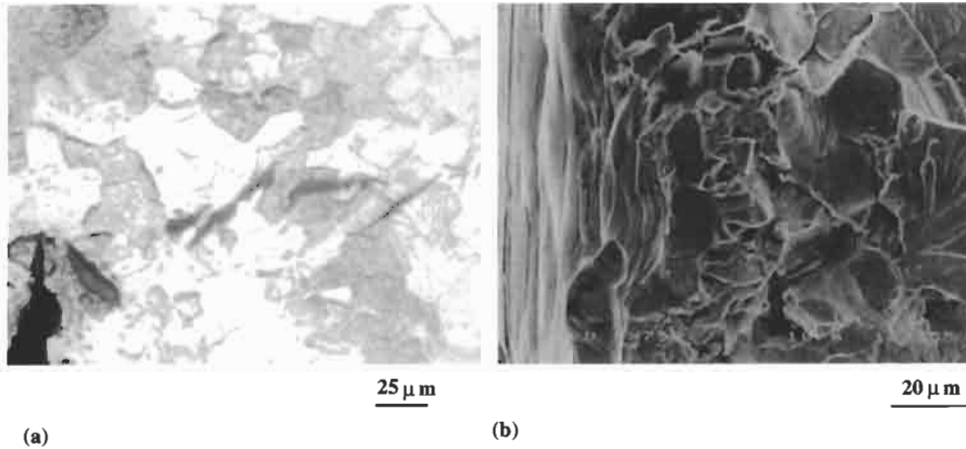
Fig. 4. Microstructure of cracks and SEM micrographs of fracture surface in panel corner.

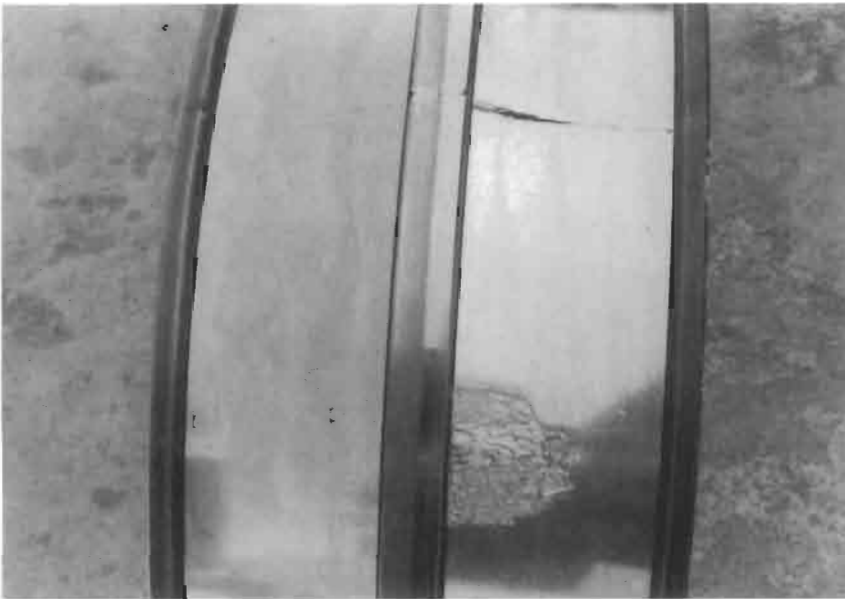
Fig. 6. Localized flaking damage on the inner ring of a thrust bearing.

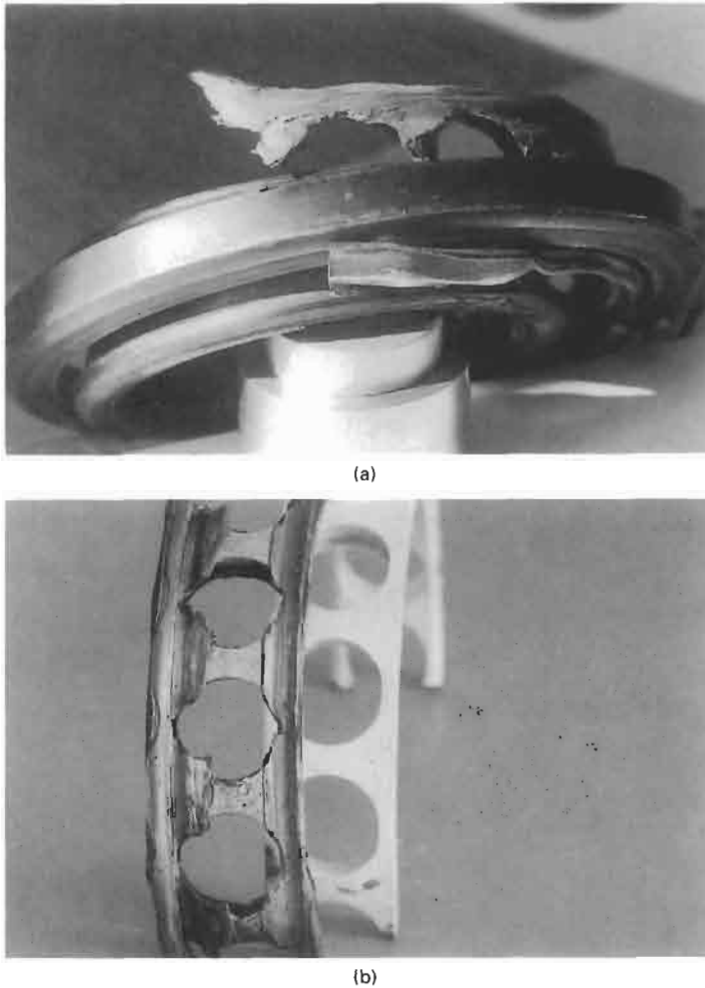
Fig. 3. (a) Probable configuration of bearing components after mishap. (b) Retrieved cage compared with the new one.

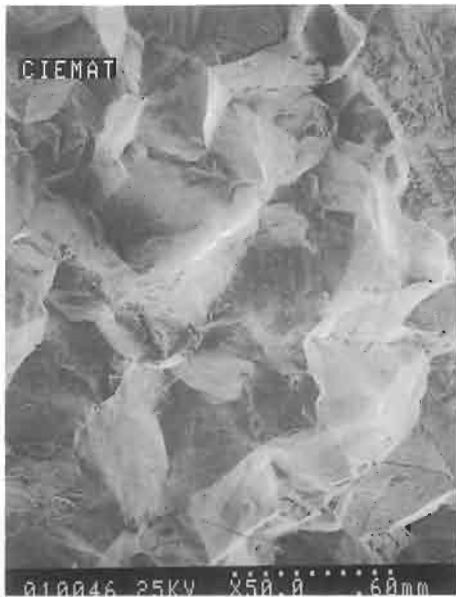
Two different metallographic sections can be seen in Figs 7 and 8. Figure 7 shows a macro-

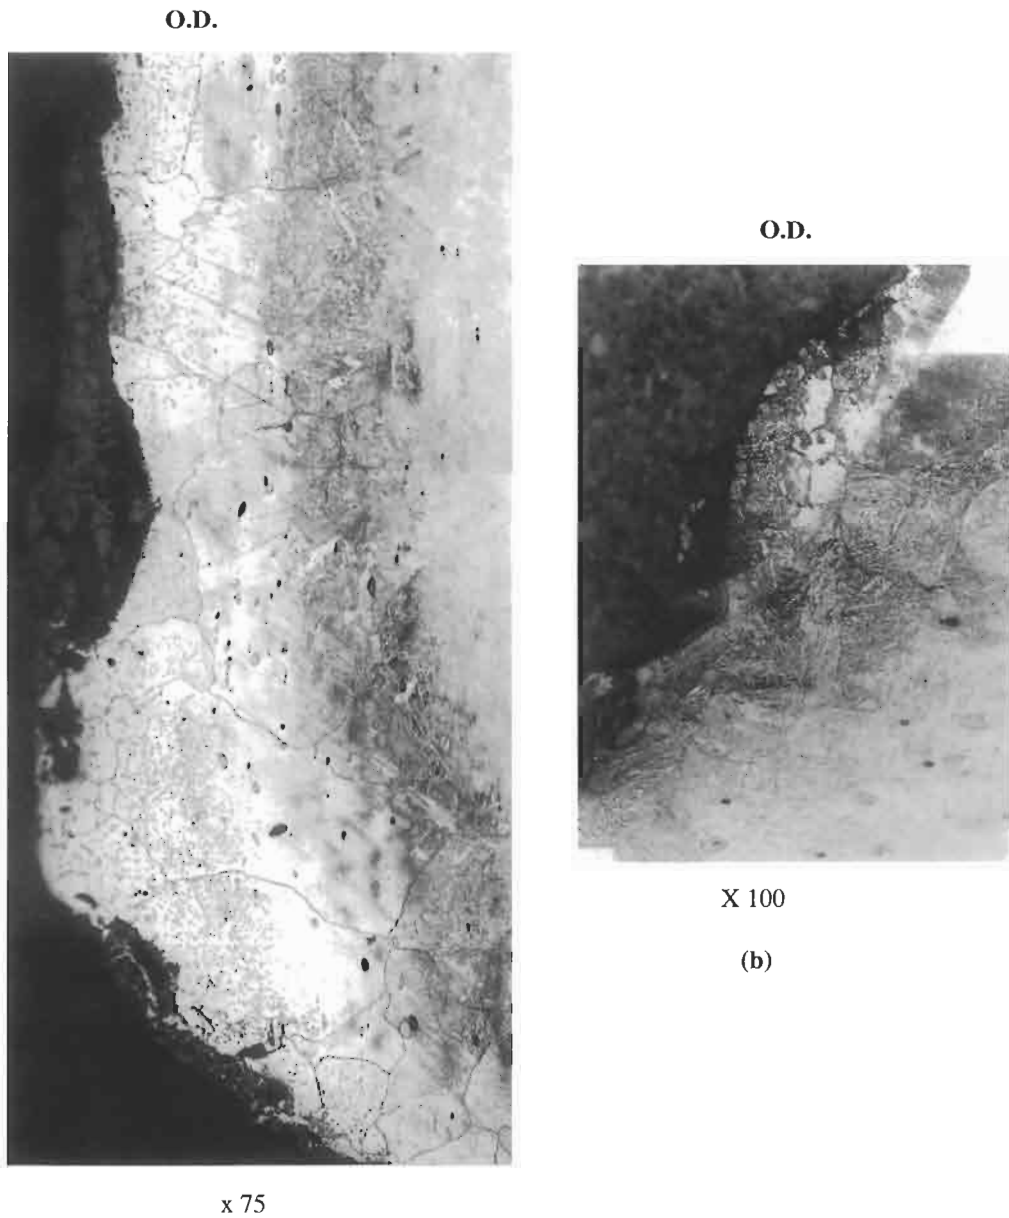
Fig. 13. Metallographic sections, after etching, close to the fracture surface of the chromium-plated sleeve (OD).
